# Manhole Inspection Summary

Manhole # S29Q\_\_037MH

Insp Date: **11/4/08 10:26 AM**

**Location** Address: **710 W. Ostend**

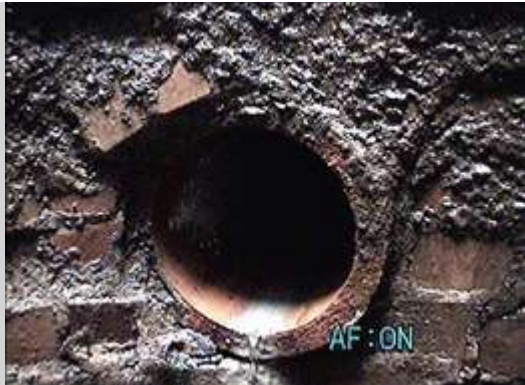
Pipe In @ 8 O'Clock

8 in. Circular Gravity Sewer

Pipe Height: **8.4** (in.) Rod and Bar (Angled)

Infiltration: **None** Pipe Seal Cond: **Sound**
